Archaeological Assessment: Edendale SH1 Realignment Project

Telephone: +64 3 363 5400
Date: October 2016
Reference: V8700.00/216RS
Status: Final

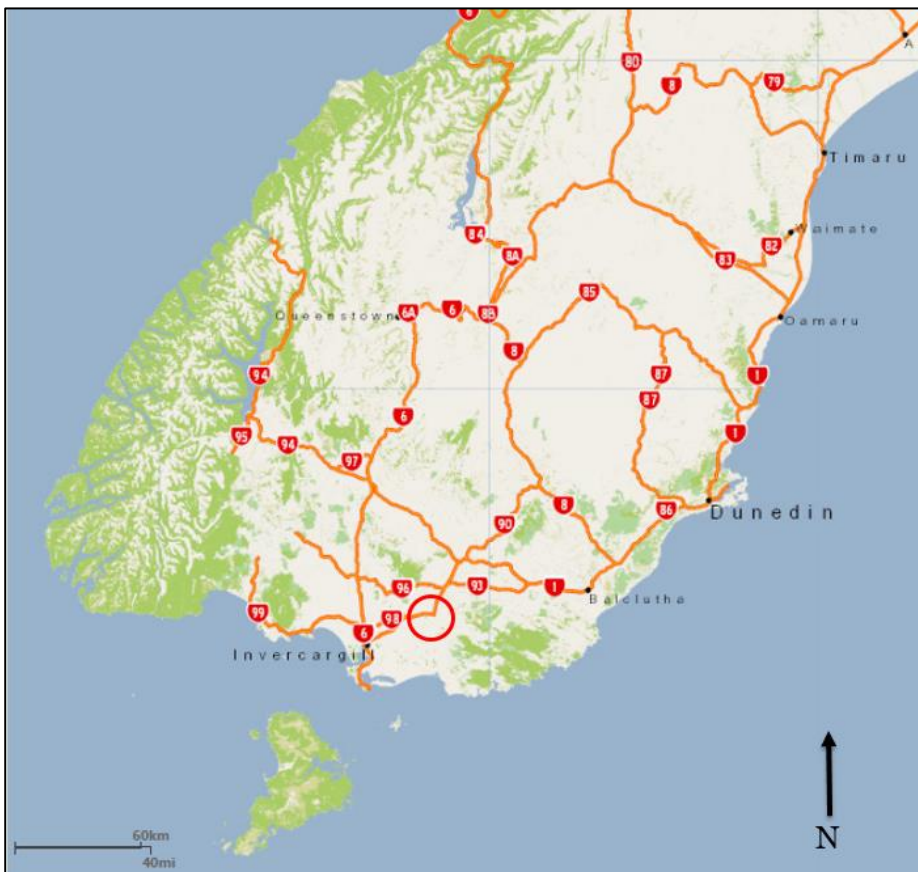
Figure 1. Map showing location of the project area/Edendale SH1 Realignment Project (red circle) in the wider geographical setting (ArchSite 2016).

The project area, which is in the vicinity of the town of Edendale, is located approximately 35 km northeast of Invercargill, Southland (see Figure 1). The extent of the project area includes land directly northwest of Edendale, to the north and west sides of SH1 (see Figure 2).

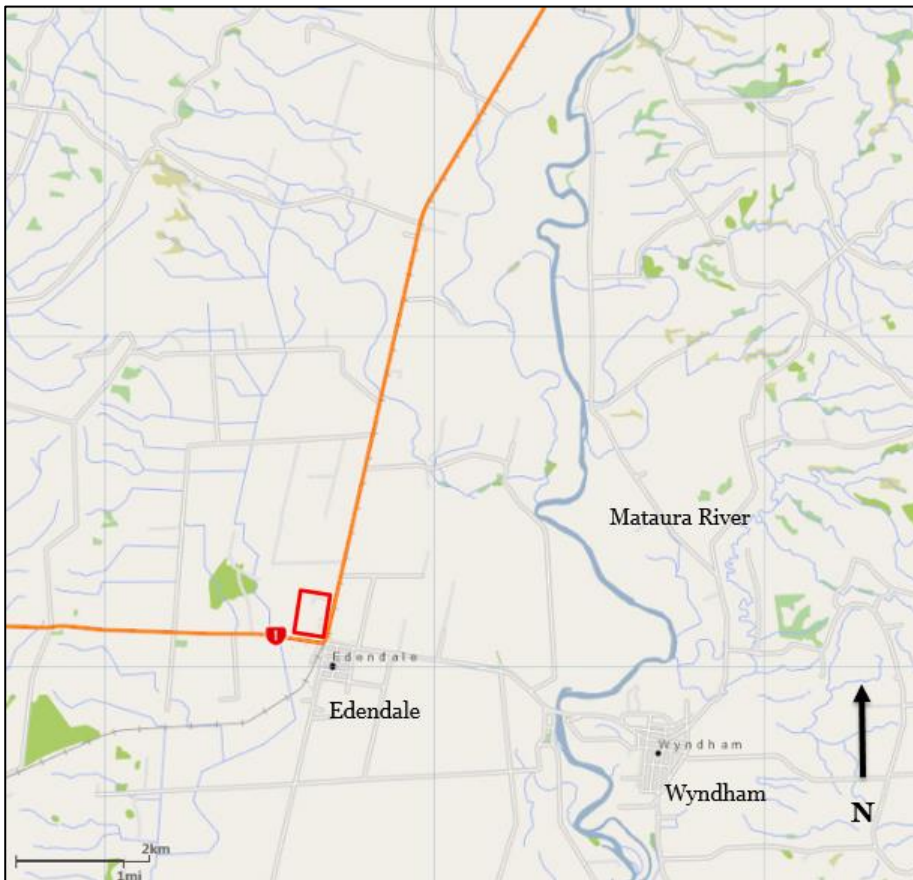
Figure 2. Map showing project area (red rectangle) relative to the town of Edendale (Source: ArchSite 2016).

The SH1 Realignment Project project involves construction of a new, c. 2 km long realigned SH1 to the northwest of Edendale with a roundabout close to the southern end of the new alignment. The new highway alignment would cause SH1 to bypass Edendale township and a Fonterra factory site located in the town (see Figure 2).

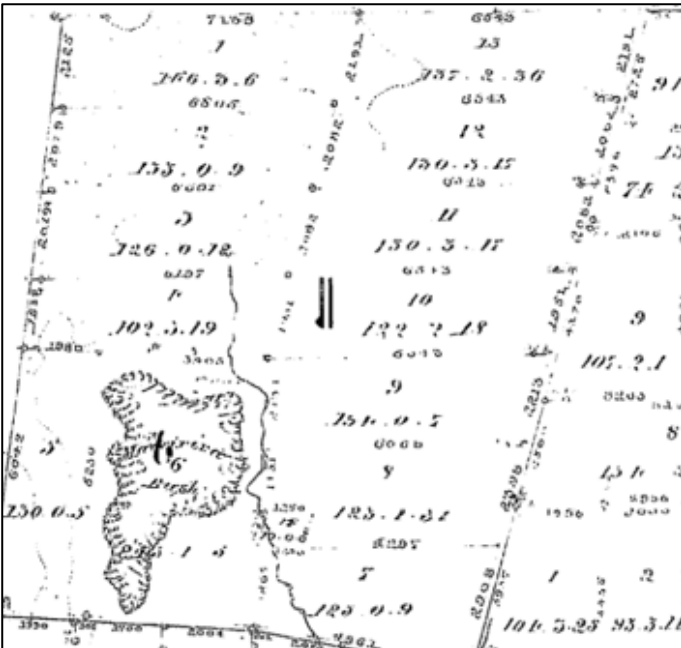
Figure 4. Part of 1866 Survey Plan (SO 593) showing ‘Block II Mataura Hundred’. The triangular element depicted in the survey is the Mararua Bush surrounded by open pastureland.

The estate at Edendale included a number of historic sections that formed one large land block called ‘Block II Mataura Hundred’ (SL25/38) (see Figure 4). The historic sections that incorporate the footprint of the proposed new road alignment included Sections 6, 7, 8, 9 and 14 of that historic land block (see Figure 5). Historic survey evidence show that ‘Block II Mataura Hundred’ primarily consisted of open pasture land in the 1860s though a triangular section of bush known as the Mararua Bush is depicted on the early drawings. On one undated survey plan (which likely dates to the 1860’s), the word ‘station’ is annotated just north of the bush suggestive for the presence of a homestead at that location (see Figure 6). An 1868 newspaper account describes the Edendale Home Station as follows:

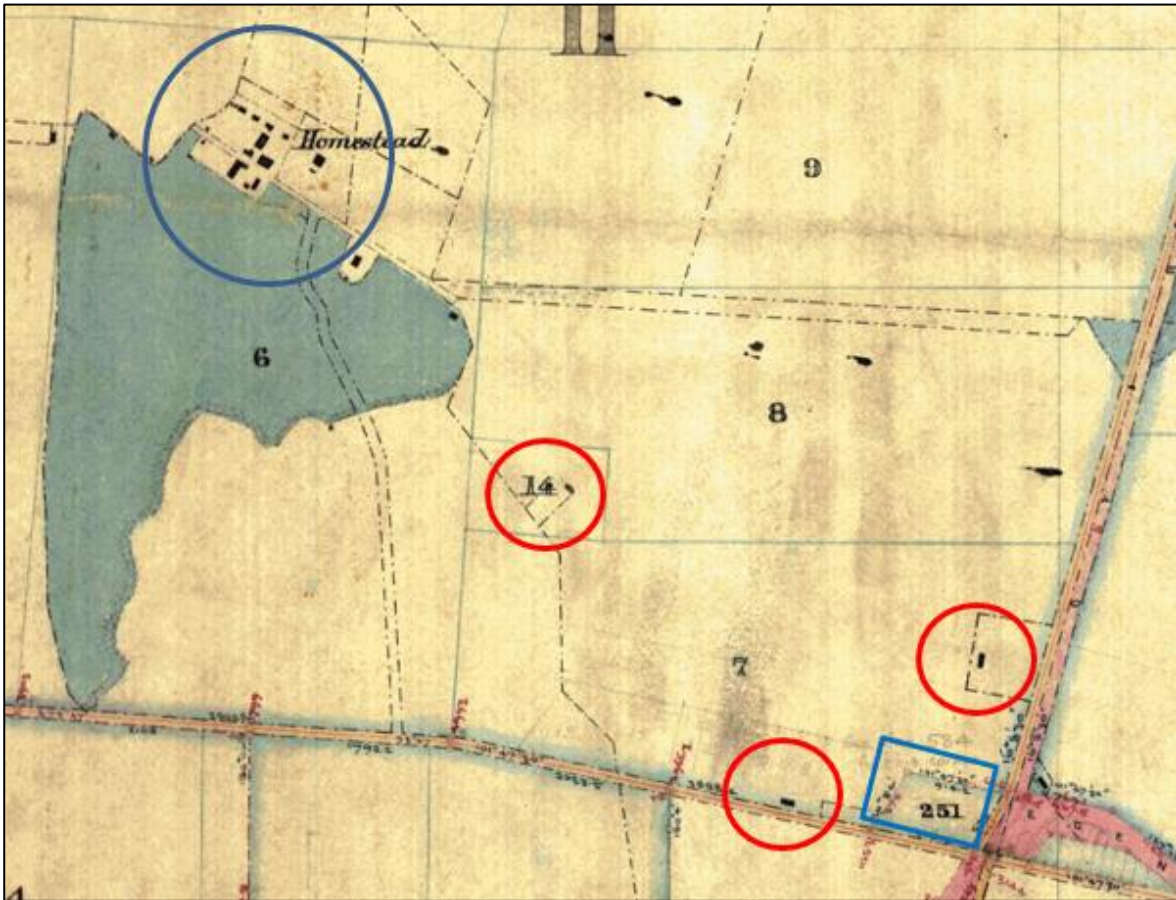
Figure 7. Part of 1882 survey plan (DP 128) showing the location of the Edendale Homestead (blue circle), the Edendale Dairy Factory (blue rectangle) and nearby estate buildings (red circles).

Opus Archaeologist Sam Kurmann undertook a site visit on 17th October 2016. Its aim was to determine evidence for, and likelihood of, archaeological remains within the project area that might be affected by project works. This included a walk over of the proposed road realignment and a visit to the location of one of the estate buildings depicted in the 1882 survey plan that is located west of the road realignment and at a remove from the Homestead and Factory (see previous Figure 7).

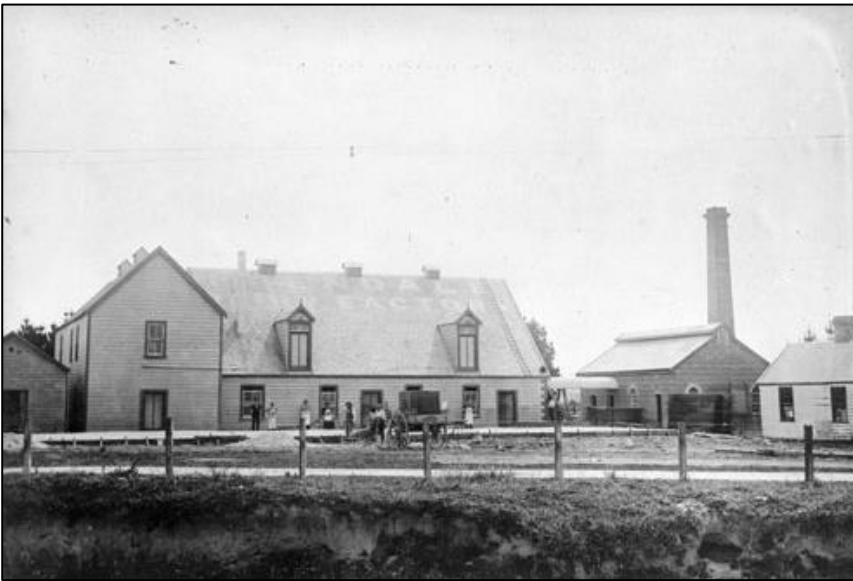
Figure 9. Edendale dairy factory, 1895 (Source: Te Ara: The Encyclopaedia of New Zealand).

In 1881 Thomas Brydone, Superintendent of the New Zealand and Australian Land Company, suggested that the company's Southland holdings be converted to dairying. In 1882, he built New Zealand's first dairy factory at the estate in Edendale. An 1882 historic survey plan (see Figures 7 & 8) shows both the homestead (just north of the Mararua Bush) and the Edendale Dairy Factory (located next to the corner of Salford Street and North Road where the Fonterra plant is located). The homestead consists of a complex of buildings while the factory complex is depicted as consisting of three buildings. Three additional buildings at a remove from both the homestead and the factory are also present in the land block – these are situated to the north and west of the factory complex. Certificate of Title evidence suggests that the land block formed a single estate at this time (including homestead and factory) and as such the additional buildings likely form part of the wider estate complex (C/T SL25/38). An 1895 photograph of the dairy factory includes a number of buildings, some of them substantial in size (see Figure 9).

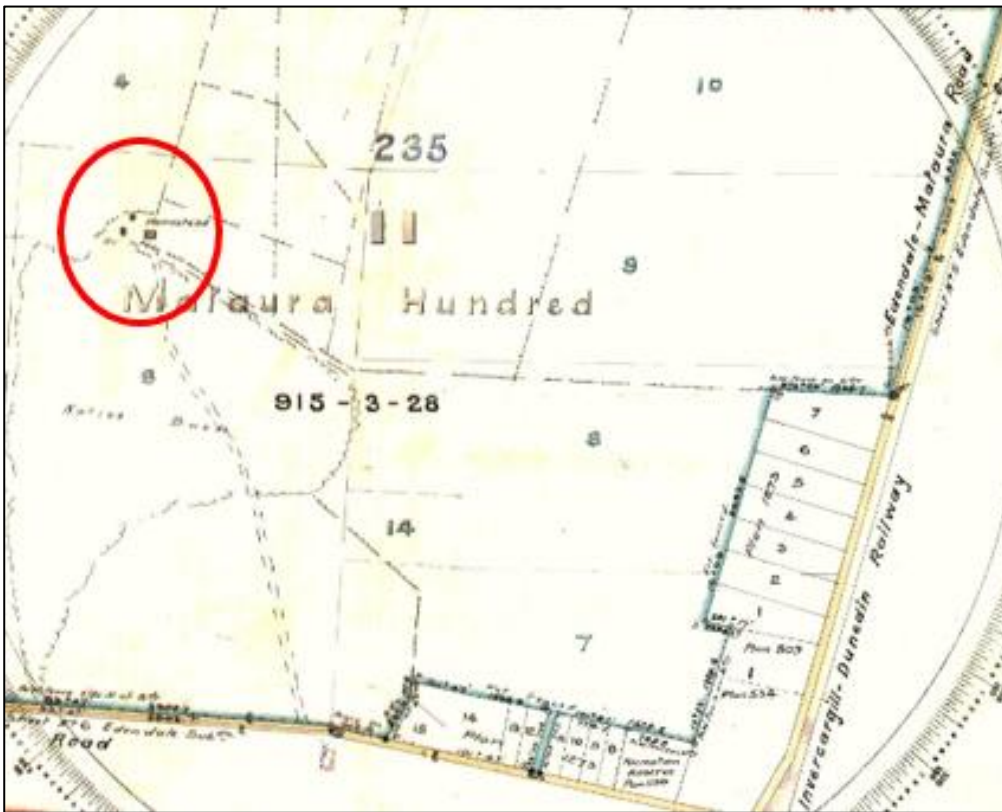
Figure 13. 1912 Survey Plan (DP 1419) showing the project area. The Edendale Homestead is depicted on the drawing (red circle).

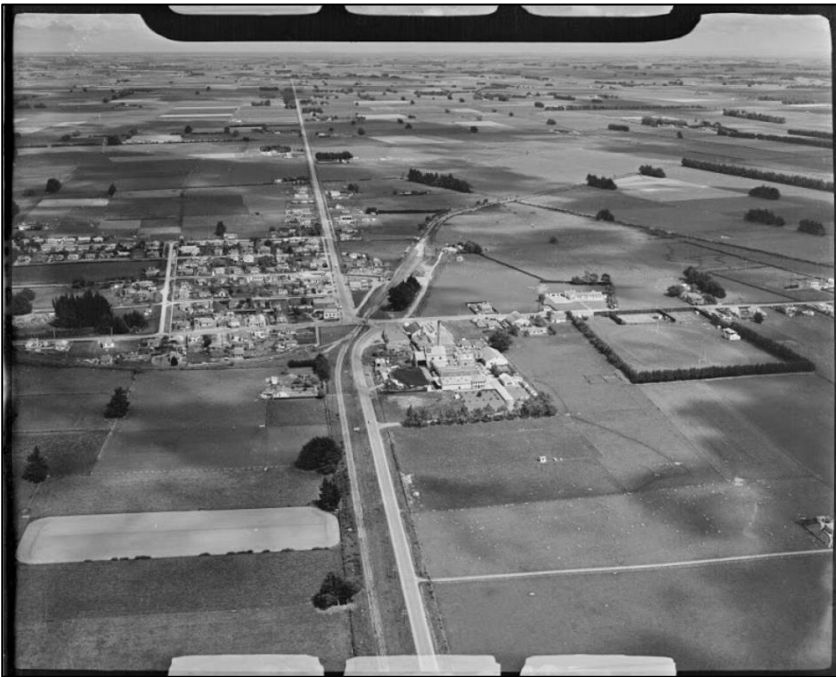
Figure 15. Aerial view of Edendale in 1956 with the station and dairy factory in view (Source: Client supplied image).

Consulted 20th century survey plans and Certificate of Title evidence indicate that sub-division of 'Block II of Mataura Hundred' did not happen until the early 20th century. The factory was sold in 1903 to the Southland Dairy Co-operative who operated the facility until Fonterra took over in 1976. The homestead was bought in 1902 by its former manager, Mr Donald Macdonald (Beck et al 2008:112). A 1926 panoramic picture of the homestead shows flat, empty paddocks surrounding the homestead complex (See Figure 14). Later aerial images show the factory had expanded northward but was surrounded by expanses of flat pasture land (see Figures 15 – 18).

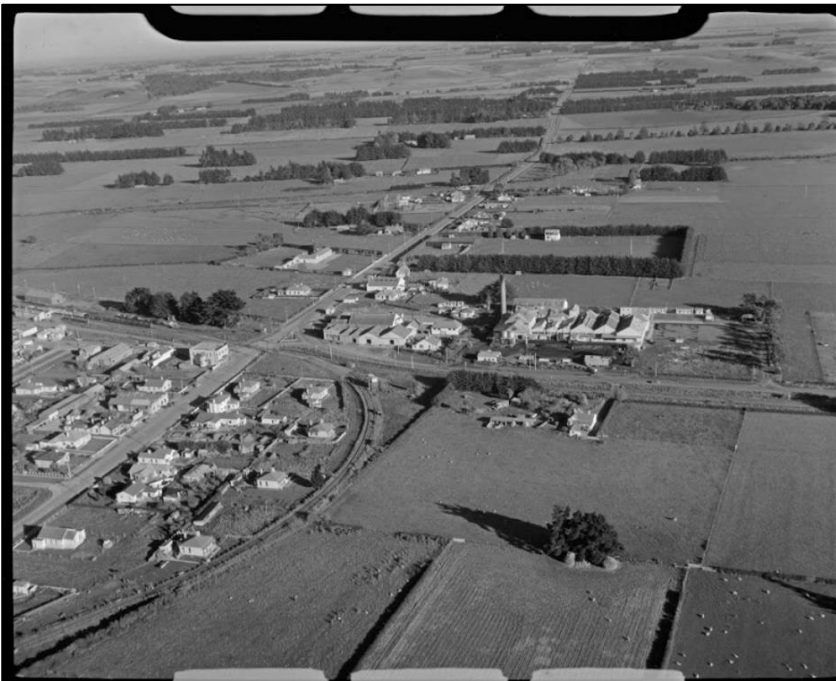
Figure 16. aerial view of the Edendale Dairy Factory in 1955 (Source: Client supplied image).

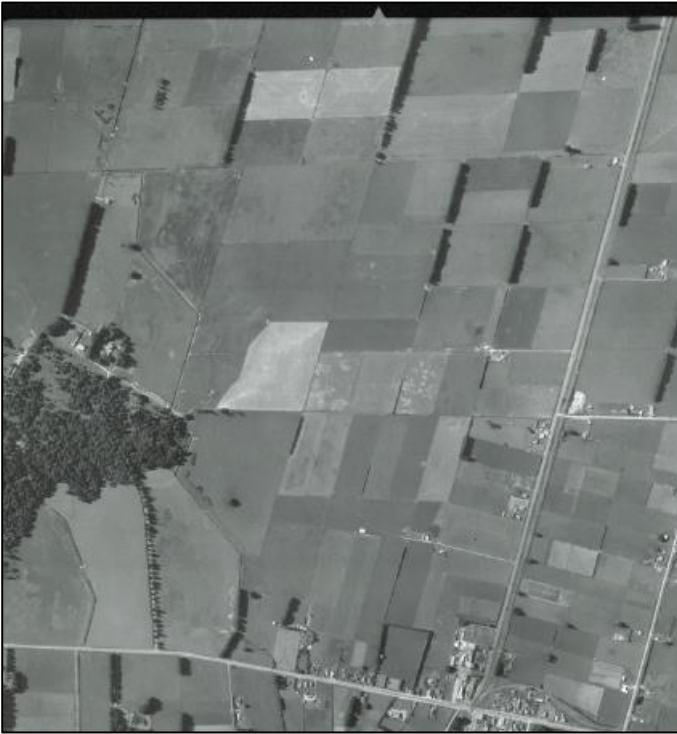
Figure 17. 1958 Aerial photograph showing the project area (Source: Client supplied image).

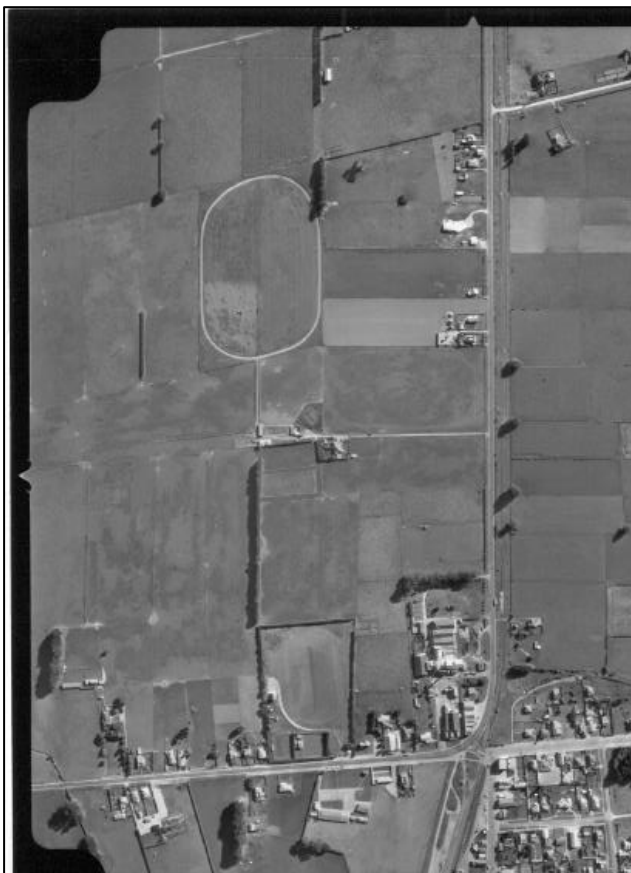
Figure 18. 1971 Aerial image showing Edendale and the project area (Source: Client supplied image).

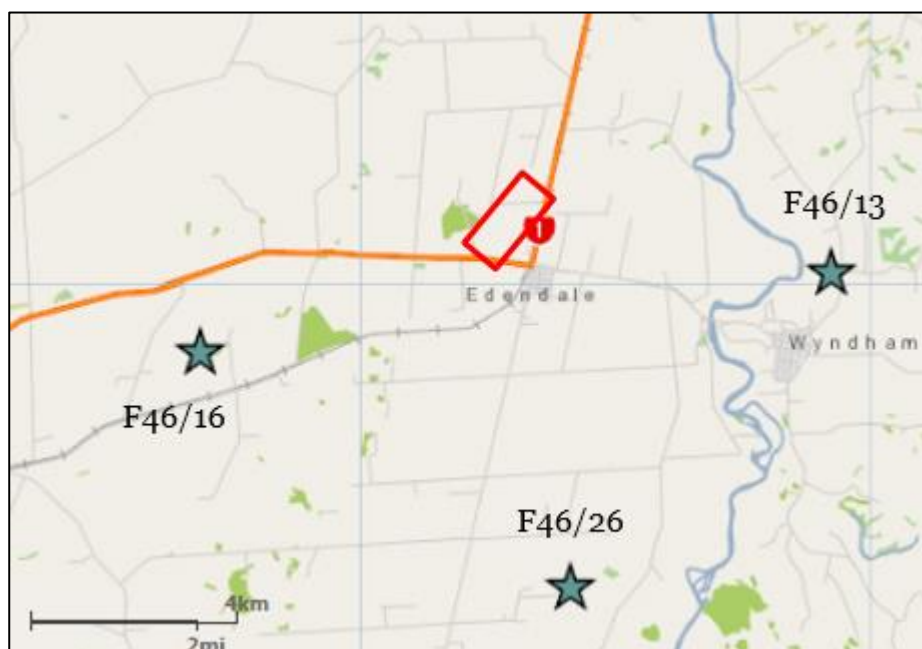
Site location information in the database is variable, and is only considered accurate to within 100 metres. This is because sites are recorded using grid references on NZMS-260 topographical maps. Many sites were originally recorded on Imperial NZMS-1 maps, and later transferred onto the metric NZ MS-260 maps, introducing additional inaccuracies through the conversion process. No archaeological sites have been recorded within or close to the work footprint of the road realignment. Three recorded archaeological sites are located between 6 – 6.6 km of the project area. These include two artefact find spots (F46/16, F46/26) and a 19th century flour mill (F46/13) (see Figure 19).

Figure 19. Map showing the project area (red rectangle) and archaeological sites recorded in the NZAA database. Each green represents the index grid reference for an individual site record. (Source: Archsite, accessed 26 September 2016).

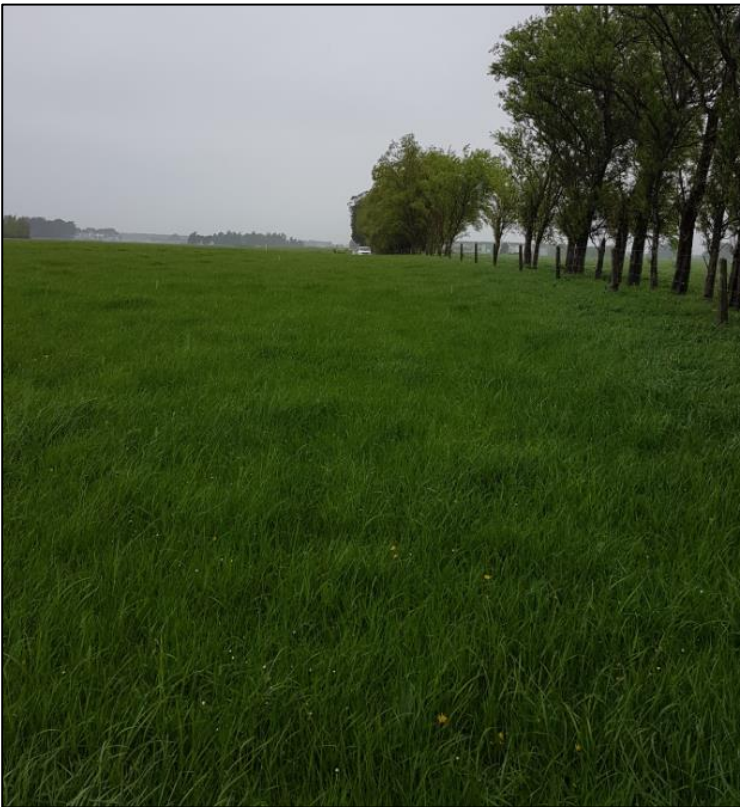
The walkover confirmed that the project footprint is characterised by flat pasture land organised into paddock field systems. Field boundaries are denoted by timber fences and tree alignments. Grass was growing in each of the paddocks (see Figure 20). No surface indicators for archaeological components were observed during walkover of the route of the road realignment.

Figure 20. Typical paddock that makes up the part of the proposed new road realignment at Edendale.

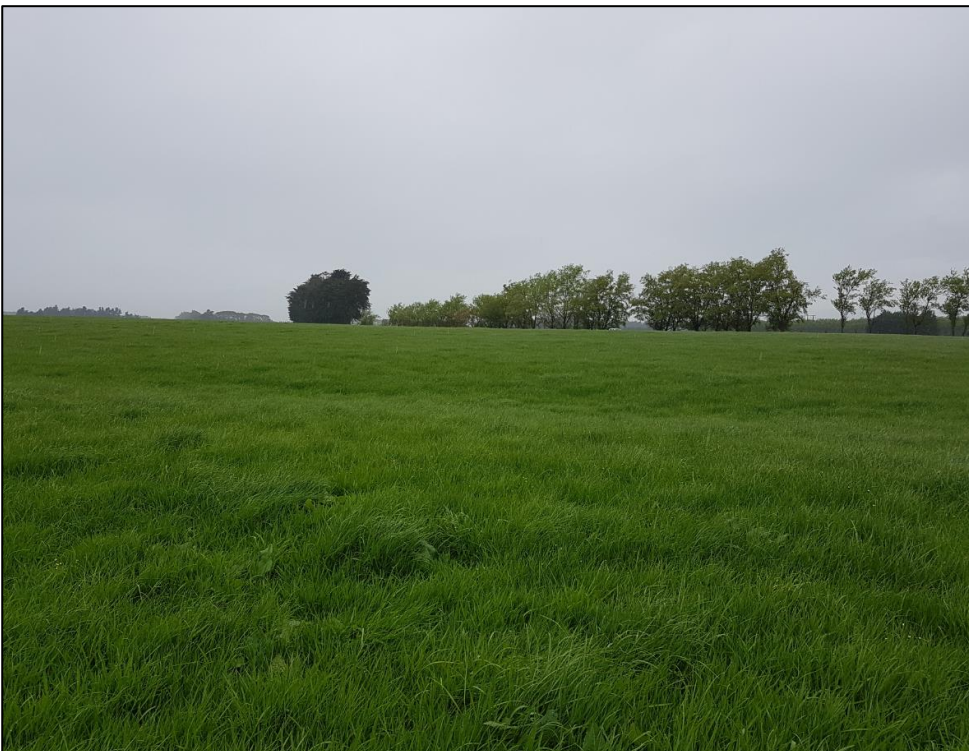
As noted, the location of an estate building depicted in the 1882 survey to the west of the road realignment route was also visited. The ground at this location was characterised by a large amorphous depression which may indicate for the remains of a building though it could also be a natural topographical feature (see Figure 21).

Figure 21. Large amorphous depression in location of 19th century building to west of the proposed road realignment.
